archaeological site

GADES

Columbaria
Roman Theatre
Salting Factory

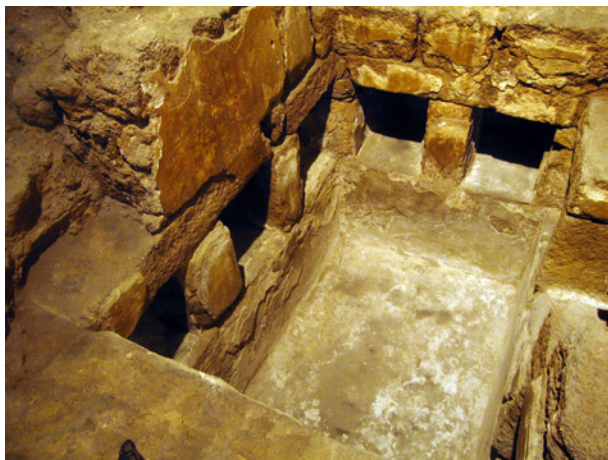
View of a columbarium, with traces of stucco

The ruins preserved *in situ* correspond to three of the five collective underground burial sites discovered. The largest, measuring approximately 2.50 x 3.75 m, is a structure of irregularly dressed calcarenite stones with a lime mortar bond that has been partially destroyed by looting since Antiquity, although significant portions of its basic components are still recognisable.

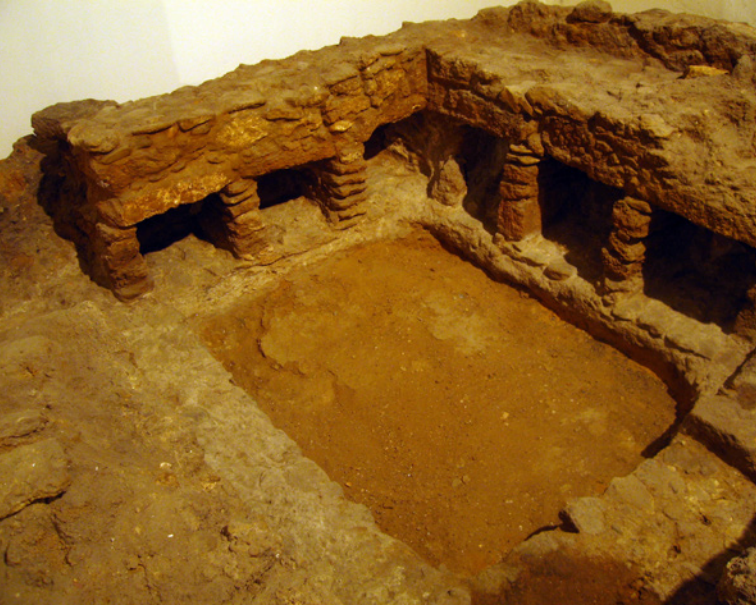
View of one of the funerary niche chambers

The shaft for accessing the burial chamber is located on one of the longer sides, and within are nine 0.35 x 0.45-metre niches for funerary urns. These openings are arranged as follows: one on each side of the entry shaft, three in front, and two on the shorter sides of the chamber. The entire structure had a white stucco finish, and there are no traces of pictorial decoration. Atop the smaller side walls we see the base of a modest barrel vault that once covered the burial chamber.

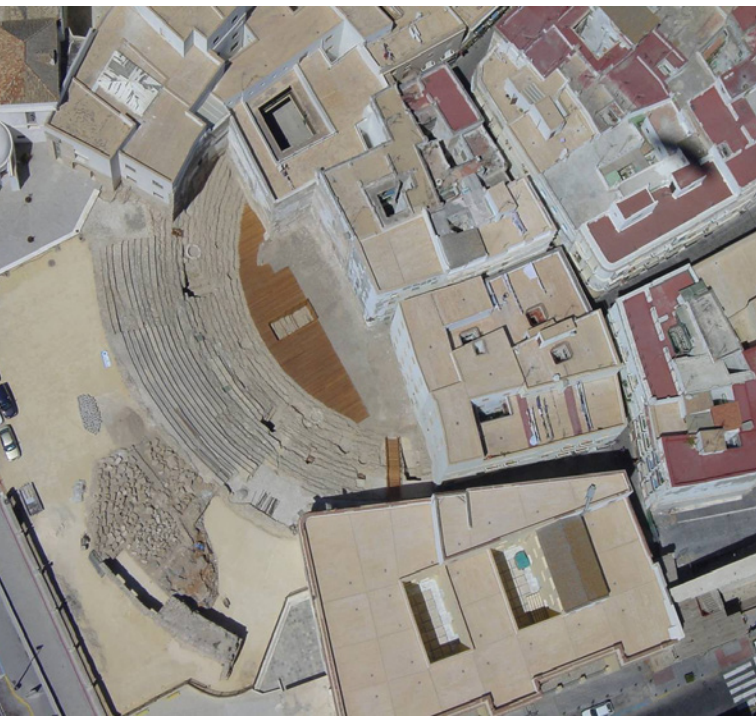
Overhead view of the excavated section of the theatre

Today we can see a large section of the seating area, which had a diameter of nearly 120 m, making it one of the largest theatres in all Hispania. The building stands on a natural cliff that was cut and prepared for its construction. The basic infrastructure consists of radial and ring walls that form a network of large cells or boxes. These helped anchor the structure to the ground and retain the fill, allowing the builders to achieve the desired incline of the seating area while also supporting its weight. A large terraced concrete surface was laid over these filled areas, and on it rested the oyster-rich limestone blocks that served as seats for theatre spectators.

A ring-shaped gallery runs beneath the seating area, 3 metres wide and 4.70 metres tall at its highest point. Two different types of masonry were used: concrete (*opus caementicium*) for the gallery's outer wall and the vaulted roof, made by repeatedly pouring concrete (five times in total) over wooden centrings whose impressions are still visible today; and ten even courses of squared stone blocks (*opus quadratum*) for the inner wall, with the bottom course resting on the soil and the topmost row supporting the vault.

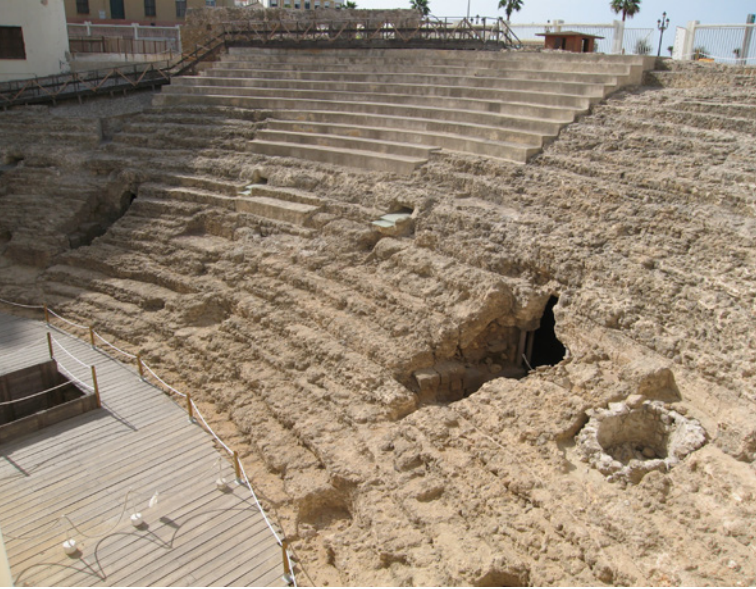
General view of the seating area

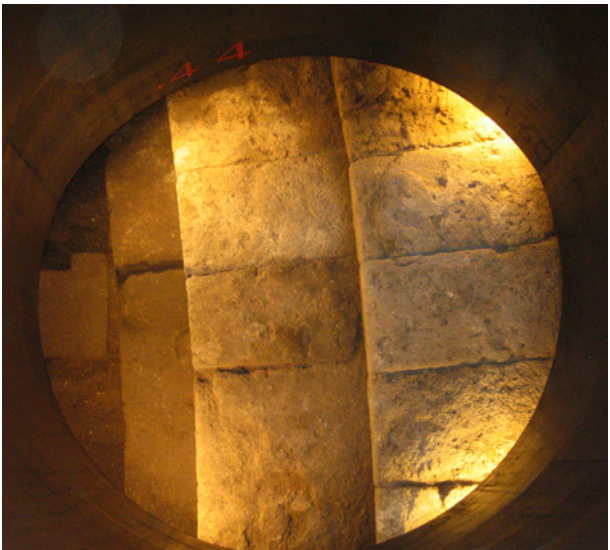
Seats beneath the Reception Centre

Surveys conducted inside the Reception Centre have made it possible to locate and inspect part of the *orchestra*, the stage structure and the lower seating area.

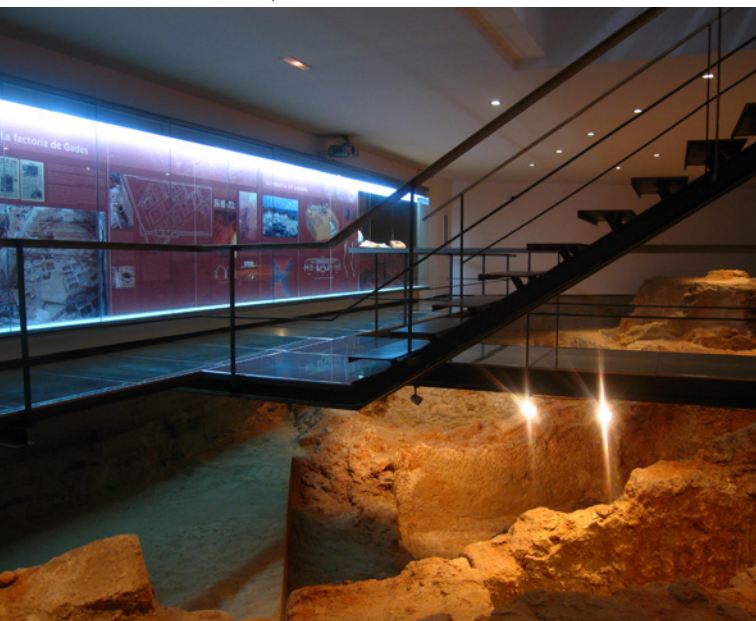
General view of the factory facilities

The ruins reveal a structure built during a boom period in the Roman city's history, in the 1st century BCE, which remained in use until it was definitively abandoned in the 5th century CE. The industrial facilities are organised around a central courtyard that was probably square in shape. Vestiges of the courtyard's lime pavement, laid directly over the sand dunes that formed the bank of a sea inlet, have been preserved. In some areas it shows clear signs of layers added to patch and repair the original paving. The floor is slightly sloped towards the centre of the courtyard, a deliberate design for draining off rainwater that would have flowed through various channels into a two-chamber cistern situated lower than the courtyard.
